# STATE OF THE TAKIWĀ

## Te Āhuatanga o Te Ihutai

## Cultural Health Assessment of the Avon-Heathcote Estuary and its Catchment

Toru / July 2007

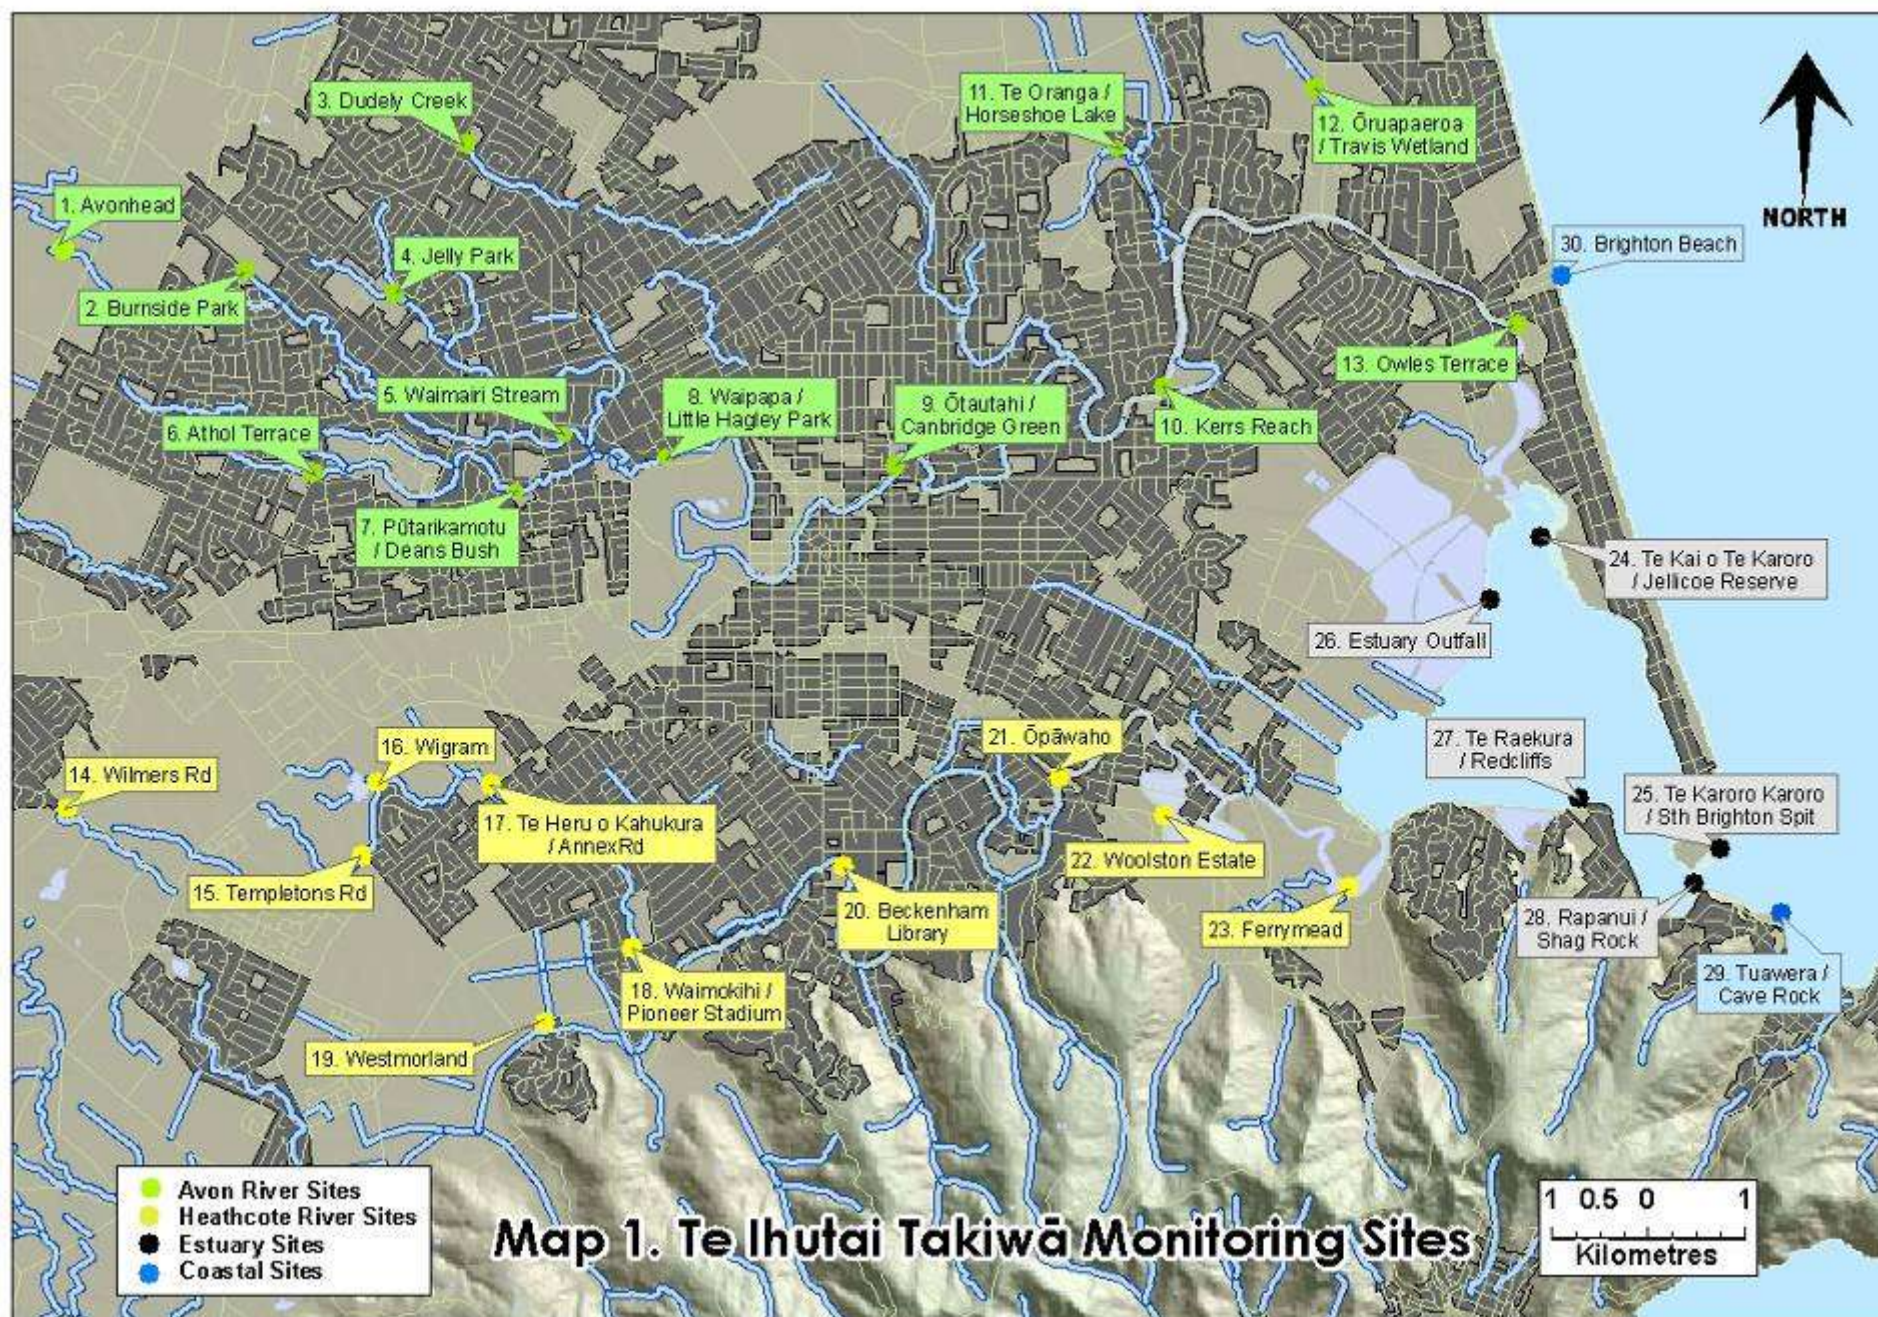
The location of these sites are shown on map 1 on the following page.

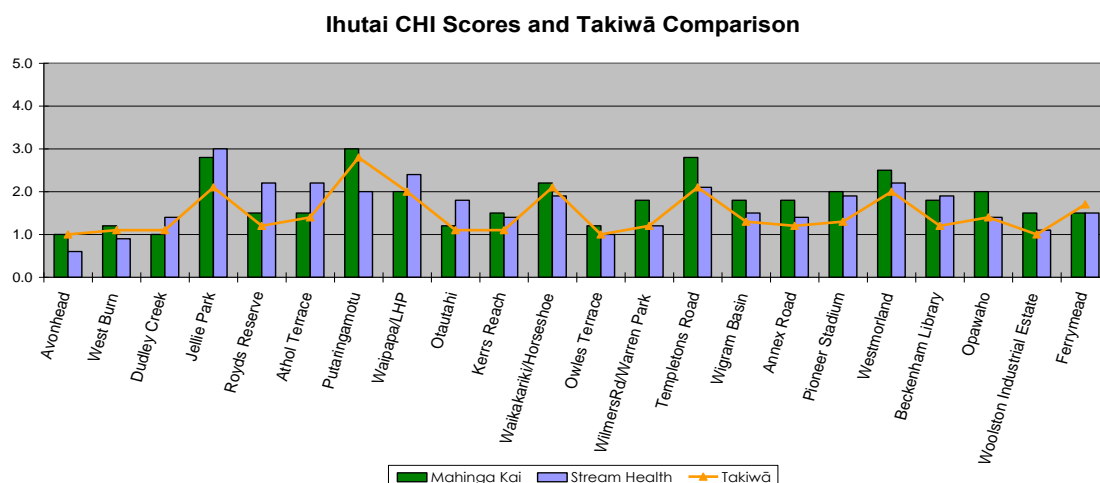
The highest scoring site under the CHI was Jellie Park (B-0 2.8 3.0) followed by Pūtārikamotu (A-1 3.0, 2.0), Templetons Road (B-0 2.8 2.1) and Waipapa (Little Hagley Park) (A-0 2.0 2.4).

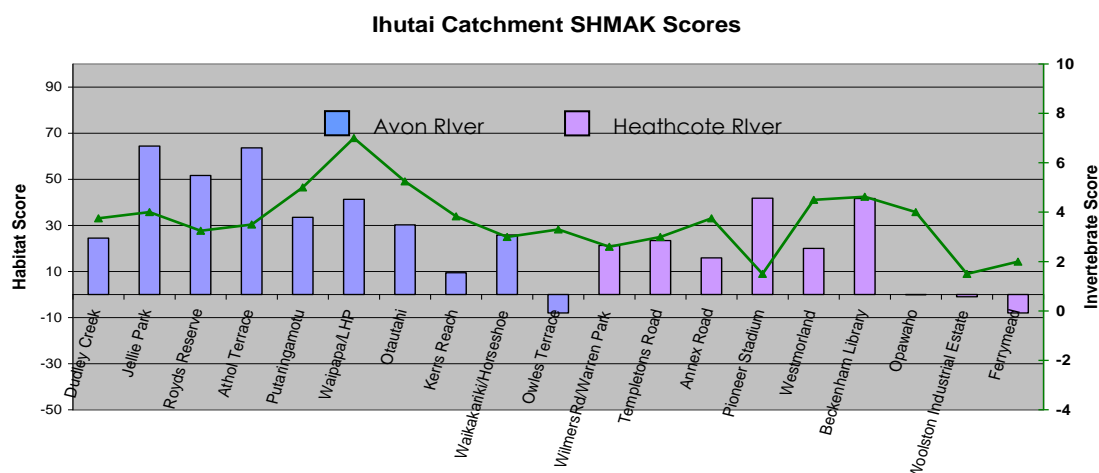
The highest scoring site under the SHMAK was Waipapa (Little Hagley Park) (41.3 & 7), followed by Pūtārikamotu (33.5 & 5), while Jellie Park had the highest stream habitat score of 64.4.

Although being poor overall, both sets of results showed that water quality in the Avon catchment was healthier than the Heathcote, particularly in relation to water clarity and sedimentation. A major factor in this result is the nature of the water sources and inputs feeding each catchment. From the site assessments, it was obvious that the Avon is heavily influenced by springs, while the Heathcote is influenced to a greater extent by stormwater inputs, including a major input feeding the headwaters at Wilmers Rd/Warren Park.

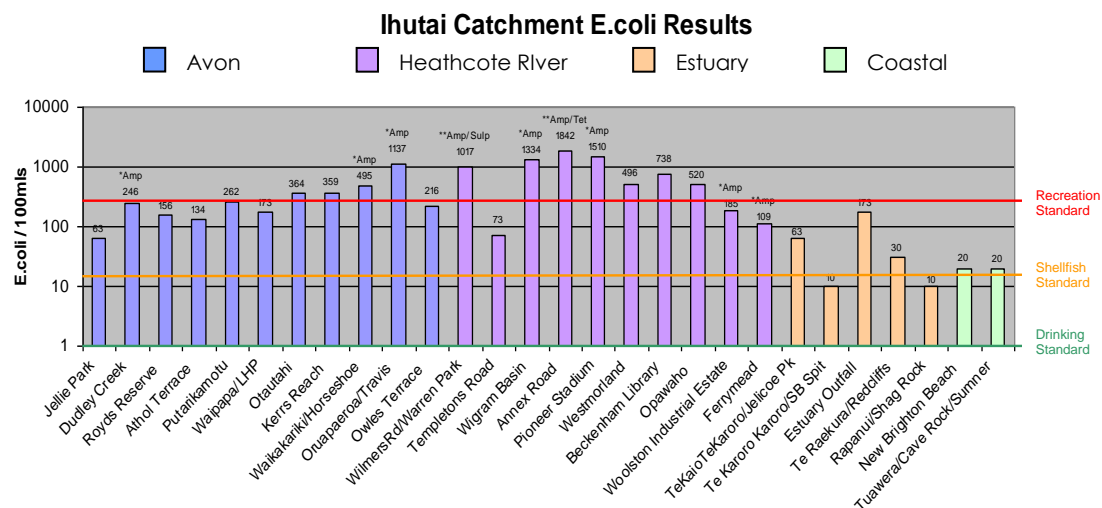
E.coli results within the Ihutai catchment were very poor, with 43% of all sites failing the recreational standard for water quality (260 E.coli/100mls) and only 7% or 2 sites, South Brighton Spit and Shag Rock, achieving the shellfish/food gathering standard (4-14 E.coli/100mls). No sites were fit for drinking. Moreover, a number of sites had alarmingly high results, the worst being Annex Road (1842 E.coli/100mls), at 7 times the recreational standard. Moreover, E.coli at this site were resistant to 2 different strains of antibiotics (Ampicillin and Tetracycline).

E.coli at 32% of all sites sampled (9 out of 28) showed resistance to antibiotics, with Ampicillin being the most common (all 9 cases), as well as Sulpha and Tetracycline in 1 case each. Anti-biotic resistant e.coli was found at sites throughout the catchment, indicating widespread contamination, including: Dudley Creek, Waikākāriki, Ōruapaeroa (Avon), Wilmers Rd, Wigram Basin, Annex Rd, Pioneer Stadium, Woolston Estate and Ferryroad (Heathcote).

These results are shown in the graph below.

E.coli results for river sites were worse than those for estuary or coastal sites, with the exception of two spring influenced river sites, Templetons Road and Jellie Park, which were relatively low. The Te Karoro Karoro (South Brighton Spit) and Rapanui (Shag Rock) sites were the only sites to achieve the shellfish gathering standard, both being estuary mouth sites with significant coastal water influences, while the Heathcote results were poorer than those for the Avon.

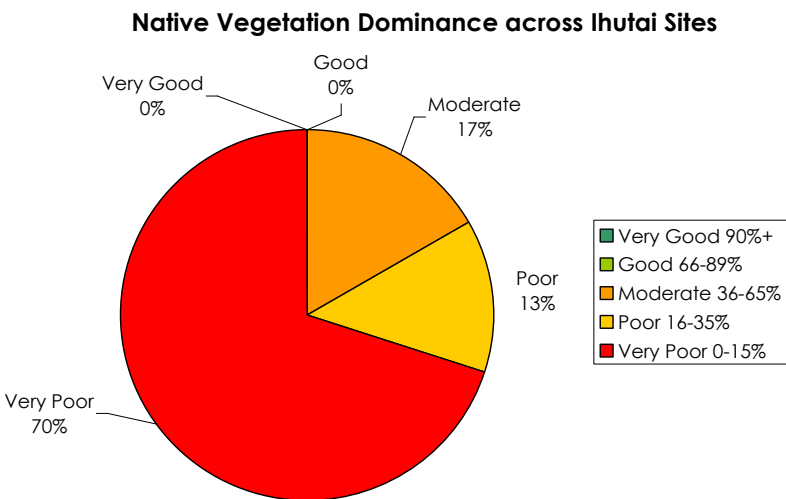
In terms of native vegetation dominance, results were very poor. 70% of all sites had less than 15% of the total vegetation cover as natives, with a further 13% of sites being between 16 to 35% dominant. 17% had moderate native vegetation dominance (between 35-65% dominant), but there were no sites with greater than 40% of native vegetation dominance.

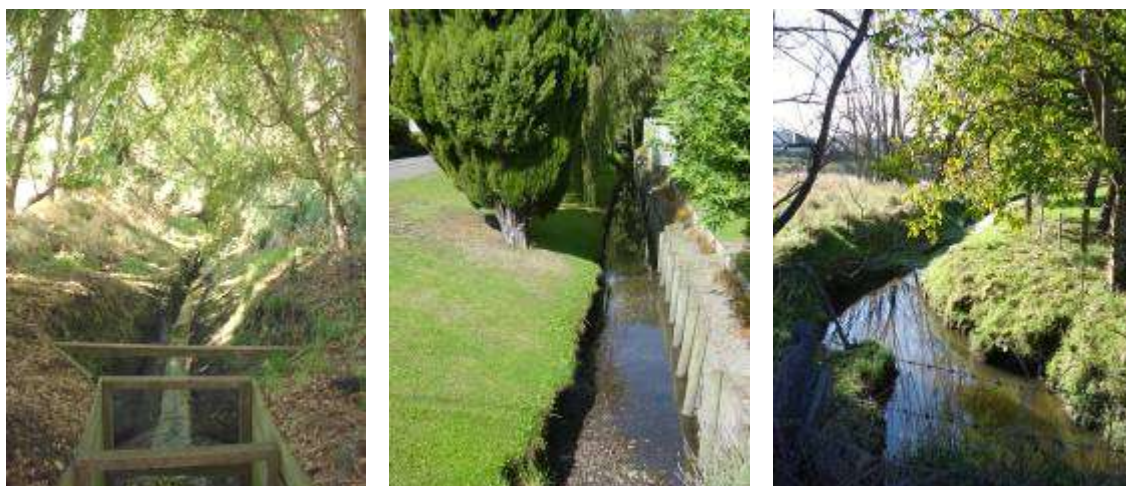
Overall, the biggest influence on poor catchment health is the historical and continuing impacts of drainage and untreated stormwater. The impacts of historical drainage were obvious at a number of sites, leaving dramatic and thick sedimentation, particularly in the lower and tidal zones of both river catchments and into the estuary. Ongoing stormwater inputs were also obvious at a number of sites, causing the clouding of water and conspicuous deposits on the streambed. The most striking example of this was the stormwater drain feeding the headwaters of the Heathcote River at Warren Park/Wilmers Road. Another example of note is Horseshoe Lake, where four stormwater inputs drain urban and rural lands from Shirley, Burwood and some of the Marshlands area into this significant traditional food gathering area.

Drains or waterways? These photos show common scenes of the upper Avon and Heathcote Rivers, where natural waterways, now resemble drains. L-R: Wilmers Rd area; Dudley Creek & Wigram Rd area.

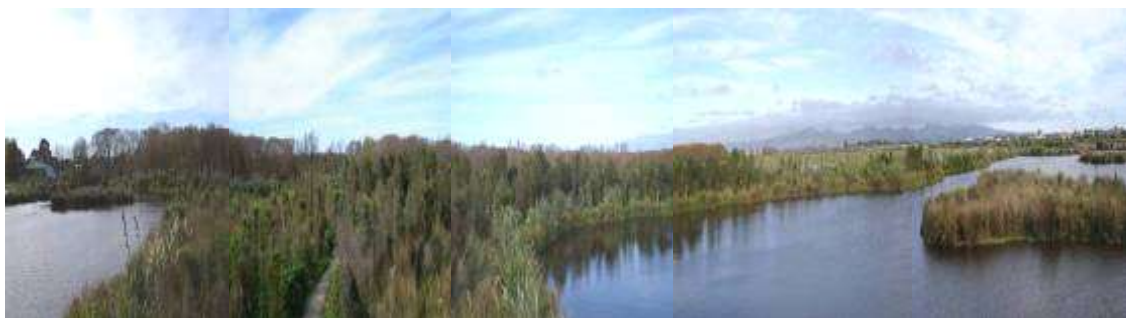
Another significant issue is the loss original native vegetation cover, including the extensive wetlands and grasslands as well as podocarp forests of pre-and early European Christchurch. While a lack of native vegetation was common throughout the catchment, particularly around the estuary itself, where areas of native vegetation still remain, or have been restored, such as Pūtārikamotu (Deans Bush), Ōruapaeroa (Travis Wetland), Waikākāriki (Horseshoe Lake) and the Wigram Basin, they are viewed as taonga and offer potential for the future.

He taonga: Native vegetation protection and restoration at Ōruapaeroa / Travis Wetland

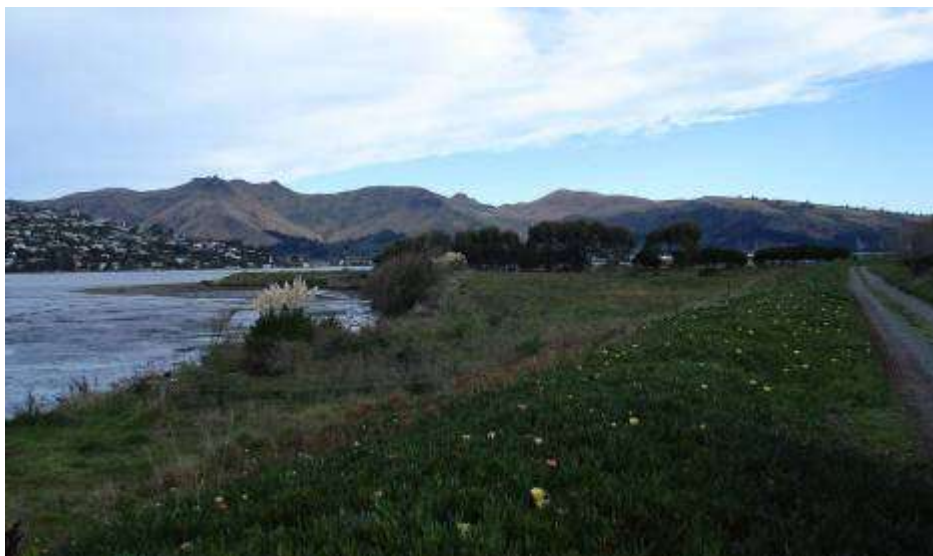
Generally, river sites, in particular specific sites in the Avon catchment and the riparian margin of the Heathcote catchment were better than those of the estuary and coast. Furthermore, native plant restoration work of the City Council was evident at a number of sites including, Jellie Park, the Wigram Basin (including Templetons Road), Pioneer Stadium as well as New Brighton Beach, positively enhancing sites. Native vegetation was noticeably absent, however, around the estuary and at Sumner Beach.

Kei hea ngā rākau Māori? A common view of the Estuary edge showing the dominance of exotic species and a lack of native vegetation.

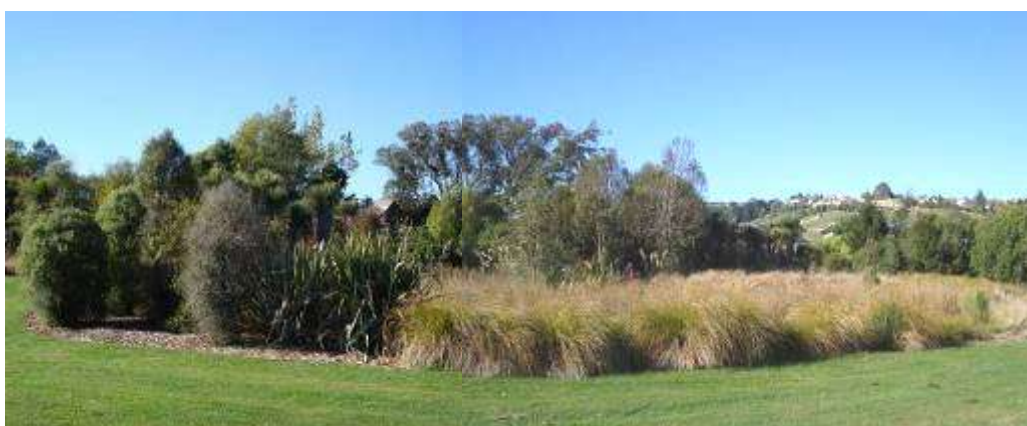
Of note was the Westmorland site at Francis Reserve which offers a great example of urban park native vegetation restoration that incorporates both tall lowland forest species providing play areas for children and habitat for native birds and insects, and low grassland/wetland species providing a buffering zone for external inputs and habitat for native waterfowl and fish.

Francis Reserve: an excellent example of urban park native vegetation including both lowland forest and wetland species.

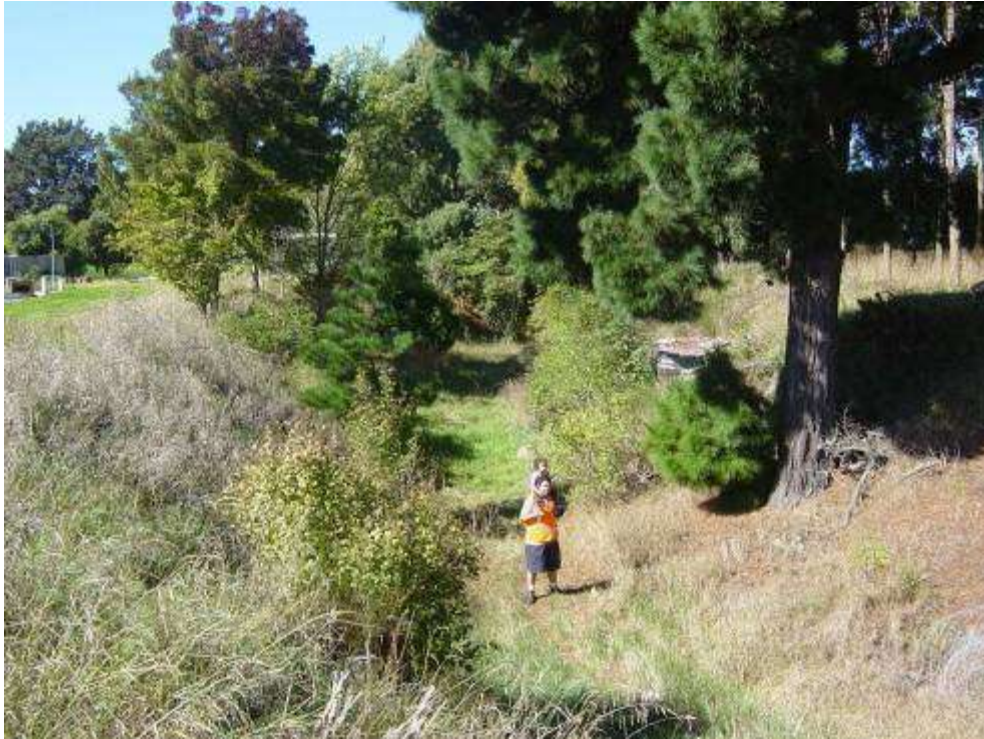
The final issue of significance is the loss of visible springs and water quantity from the catchment. This was especially evident in the upper areas of both river catchments. In particular, the upper areas of all Avon tributaries were completely dry. The most remarkable example of this was the Avonhead site across Russley Road, where an empty, grass covered 4-metre deep remnant river channel was encountered winding its way across private farmland to a bowl shaped spring-head area.

He tohu i ngā wā o mua: a precious reminder of the past, the remnant river channel found at the Avonhead site, just over Russley Road.

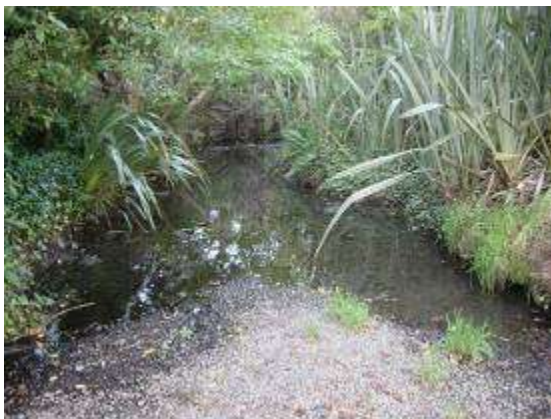
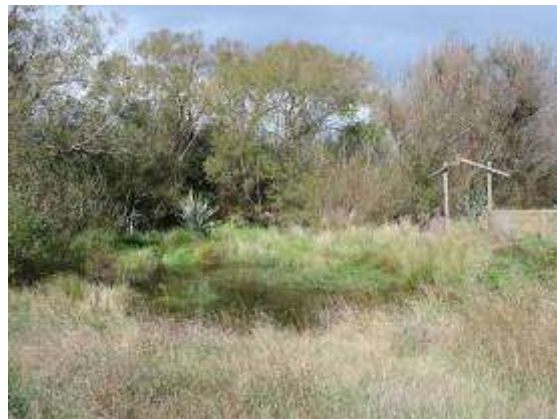
While visible springheads were rare, both rivers are still obviously influenced by spring water, particularly the Avon, which has notable water clarity down to the estuarine area. In a way, this springwater helps to 'subsidise' the health of the catchment. Furthermore, two remaining springhead areas of significance were found at Jellie Park and Templetons Road. Again, these are considered taonga and offer potential for the future, if protected and restored.

He puna wai; He tohu oranga: water spring sites at Jellie Park (left) and Templetons Road (right) showing potential for future protection, restoration and enhancement.
